ARMY RESEARCH LABORATORY

Biaxial Flexural Testing of a Carbon Fiber Reinforced Epoxy Composite

ARL-TR-221

October 1993

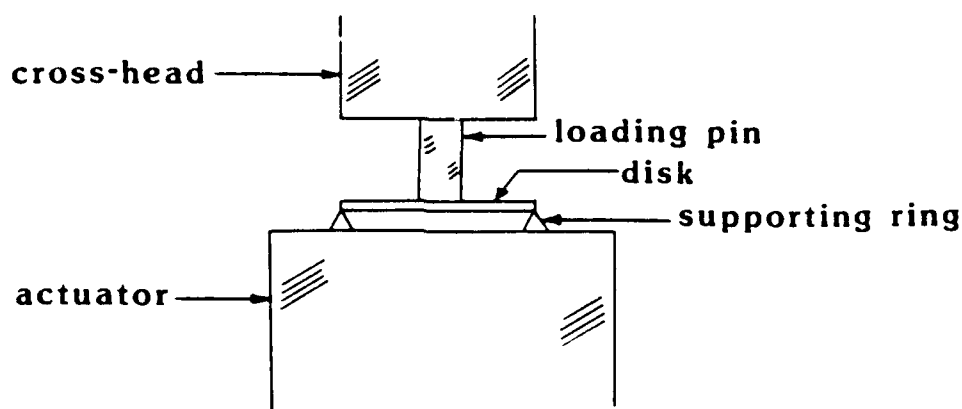
Figure 1. Loading arrangement for biaxial flexure

Monotonic and cyclic biaxial flexural tests were conducted in a 90 KN load capacity, servohydraulic test machine. Four disks were tested under monotonic and 14 disks under cyclic biaxial flexural loading. To conduct a biaxial flexure test, the composite disk was positioned on a steel supporting ring that had outside and inside diameters of 50.8 mm and 48.8 mm, respectively. Load was transferred to the center of the disk with a 12.2 mm diameter and 25 mm long steel cylinder (see Figure 1). The displacement of the loading pin (W) was monitored with the machine's actuator displacement transducer. The displacement of the loading train without a specimen was only 0.025 mm at 1.8 KN load.

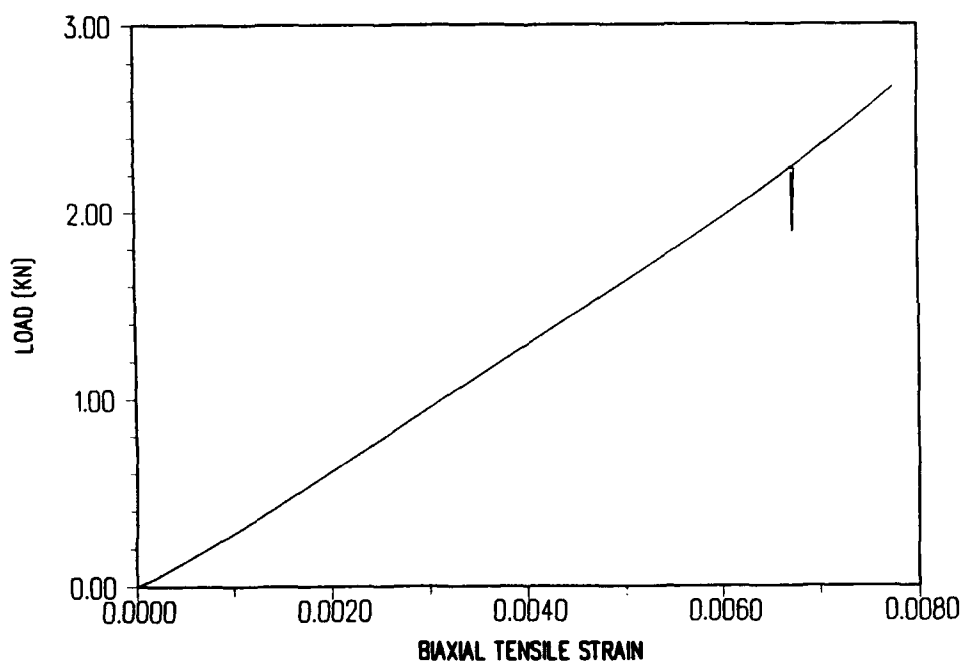
A typical relationship between the applied load and the resulting biaxial tensile strain ϵ_{xx} is depicted in Figure 2. Note that the curve is convex downward which is indicative of a stiffening process. The initial stiffness (tangent modulus) was 296 (KN/cm/cm), and the stiffness at a load of 2.2 KN was 434 (KN/cm/cm). The relationship was elastic up to 2.2 KN load and 0.0067 strain. At this strain, a *load instability* occurred.

Figure 2. Load versus biaxial tensile strain

(see Figure 2) which was accompanied by an audible sound and an instantaneous decrease of the load by 450 N. The strain at instability was 43% of the composite's uniaxial tensile strain to failure (see Table 3). Although the original curve was resumed after the load instability with continuing loading, unloading from strains greater than 0.0067 resulted in a residual strain. The latter strain could be indicative of some composite damage which was generated during or after the load instability. The stiffening of the curve continued with loading beyond the point of load instability. The final failure of the composite disk occurred by partial (through the disk's thickness) piercing of the disk by the loading pin. The pin had split the disk into two parts. One part of the disk was fully penetrated by the pin while the other was not at all. Penetration had stopped at the beginning of the central double layer (90° fibers). The fracture surfaces of the failed disk are shown in Figure 3. The peak load and the loading pin's displacement were 4.493 KN and 2.72 mm, respectively. During the monotonic biaxial loading of another disk, a load instability was noticed at a strain of 0.008. This latter strain is 52% of the composite's uniaxial tensile strain to failure. This disk was unloaded and cut with a diamond disk saw at several locations. The cross sections were polished through #600 grit paper and examined under low magnification (10X to 50X). Two cracks with planes parallel to the plies were found. Such cracks will be referred hereafter as *shear cracks*. One shear crack was located at the interface of the first 0° double layer and the first 90° double layer on the tension of the disk. The crack had an elliptic shape and was symmetric about the disk's center. Part of the crack is shown in Figure 4a. This crack was not detected by ultrasonic C-scanning or X-ray radiography. The second shear crack was located in the middle (through thickness) of the second double layer of the 0° fibers (see Figure 4b). This crack was approximately 14 mm x 14 mm off the disk's center and was detected by C-scanning but not by the X-ray radiography. The third disk failed by shear cracking at a strain of 0.0074. Finally, the fourth disk did not exhibit a load instability but instead was penetrated fully by the loading pin at a peak load of 4.2 KN and 2.5 mm pin displacement.

The response of the resin composite to biaxial tensile loading during a single cycle is depicted in Figure 2. As with the aluminum composite (1), some hysteresis was also noticed on unloading the resin composite (not shown in Figure 2). However, unlike the metal matrix composite, no residual strain was noted with the organic composite after unloading from strain as high as 0.0067. The presence of a hysteresis loop and the absence of residual strain witness a viscoelastic composite behavior below the 0.0067 strain. However, the original curve was resumed after the load instability with continuing loading, unloading from strains greater than 0.0067 resulted in a residual strain. The latter strain was the result of composite damage. Other differences in the one cycle behavior of the two composites pertain to the shape of the loading curve and the failure mechanisms. The metal matrix composite exhibited an initial linear curve which was followed by a segment of decreasing slope. The strain at which this change was observed to begin was 0.009 which is 100% of the composite's uniaxial tensile strain to failure. Beyond this point, further increase in load would cause fiber breaks under biaxial flexural loading which, in turn, would cause the slope of the curve to decrease.

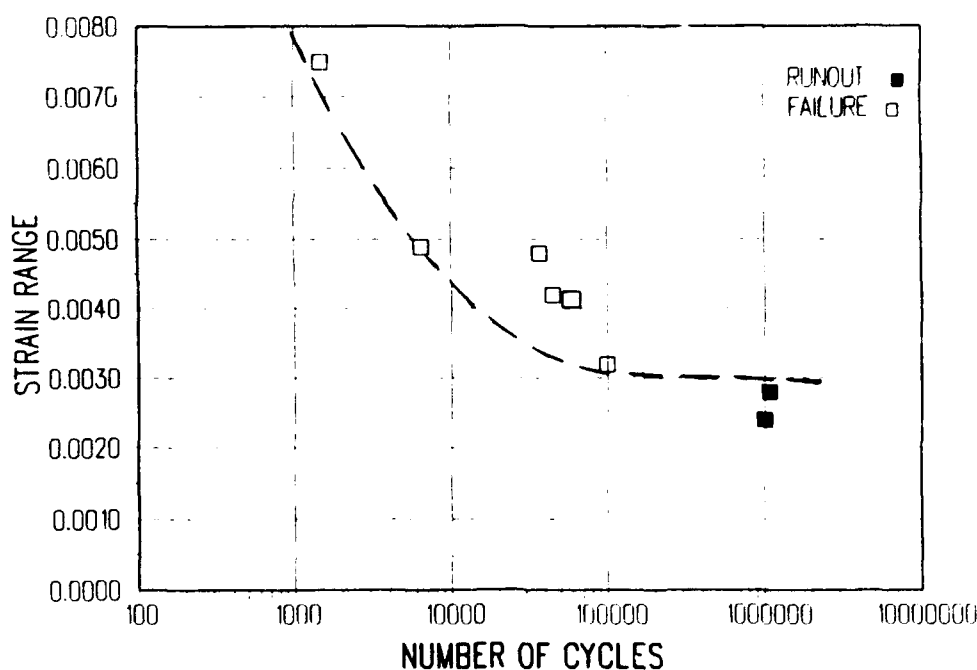
The relationship between the cyclic biaxial tensile strain range and the composite's fatigue life is depicted in Figure 5. Open symbols represent failures while solid symbols indicate runouts. The dashed line represents the envelope below where no composite failure was observed. Fatigue failure was considered to have occurred whenever a minimal decrease of 10% of the maximal cyclic load was necessary in order to maintain a constant cyclic strain range. This failure definition is similar to that for monotonic loading and is independent of the nature of the failure mechanism. The strain endurance limit under biaxial cyclic tension for 10^6 cycles of fatigue life approached 0.003. This limit is only 19% of the composite's uniaxial strain to failure under monotonic loading which is 0.0155 (3) (see Table 3).

Figure 5. Fatigue life versus strain range

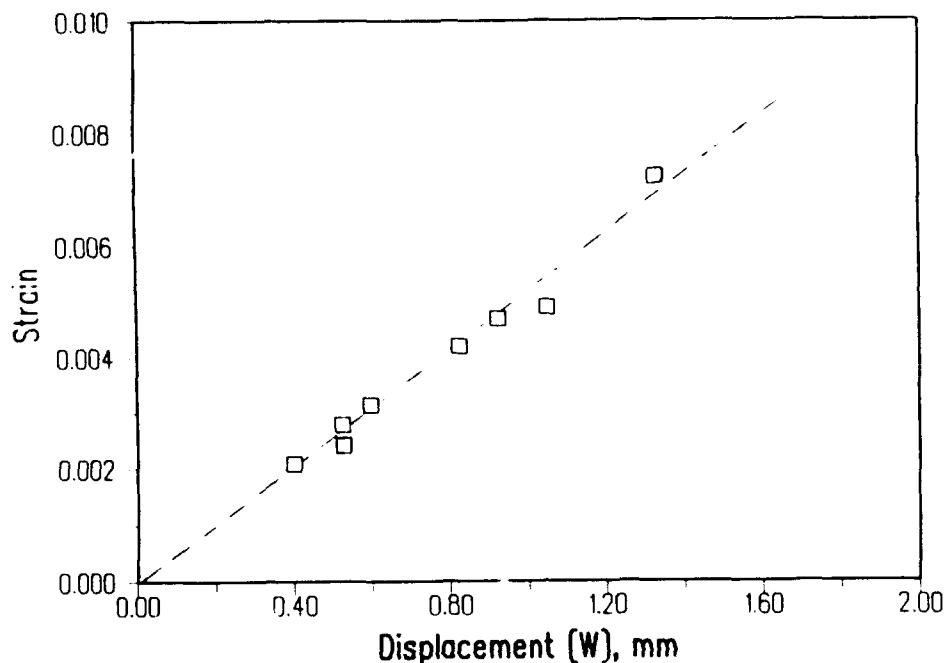
The relationship between the displacement of the loading pin and the resulting strain was linear, as shown in Figure 6. Each point shown in this figure represents a pair of the maximal cyclic displacement W and the corresponding maximal cyclic strain ϵ_{xx} of an individual disk. The dashed line represents the least square fit of all data points. The little data scatter is probably due to the variation of the composite's thickness, which was discussed earlier (see the Material, Test Specimens, and Experimental Procedures Section). Thus, both the pin's displacement W and the strain ϵ_{xx} may be

Figure 6 Strain - displacement relationship.

used as independent parameters to evaluate the response of the composite to the biaxial loading. However, since the strain ϵ_{xx} represents a local response and the displacement W represents a global response, the linearity of the relationship is expected to be destroyed after the introduction of damage in the composite.

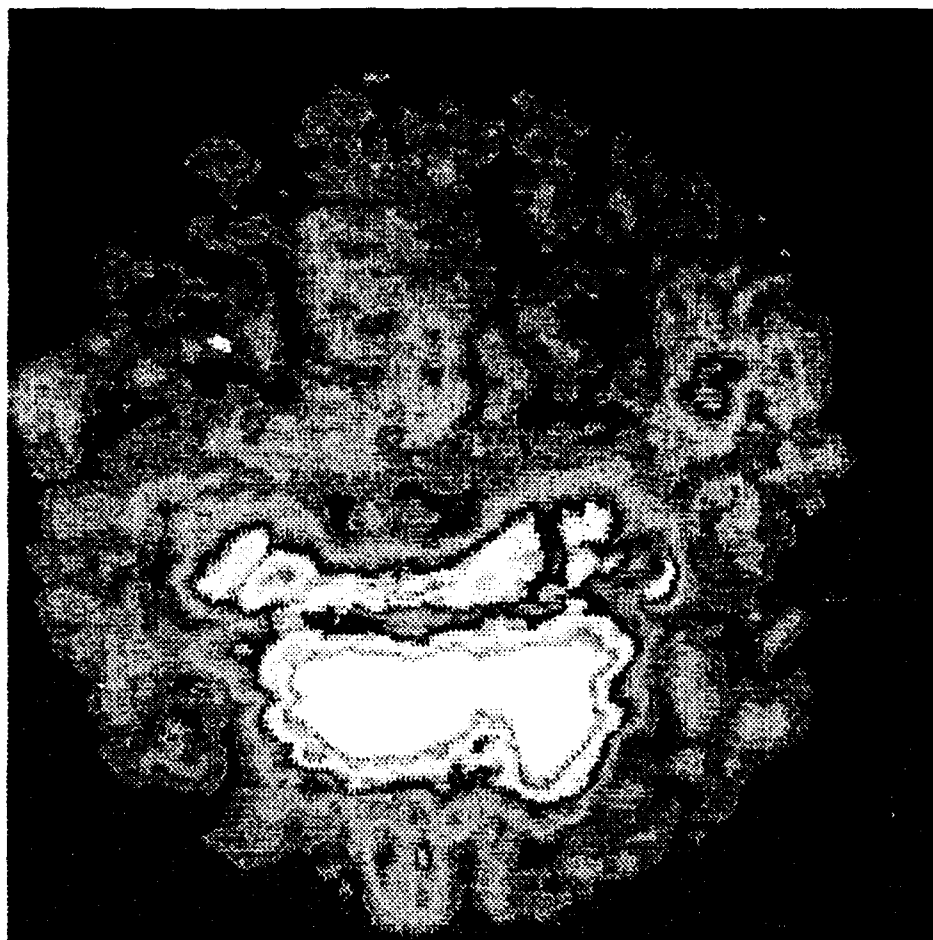
Ultrasonic examination of failed disks identified some delaminations. An ultrasonic scan of a disk with a delamination is shown in Figure 9. The delamination formed after 45,500 cycles at a cyclic strain range of 0.0042. The damaged area is off the disk's center and is elongated along the 90° fibers. In some disks which had failed in fatigue, more than one shear crack had formed. The white areas shown in the C-scan of Figure 10 represent delaminations which are not all coplanar and were generated after 1100 cycles at a cyclic biaxial tensile strain range of 0.0072. The delaminations caused the maximal cyclic load to decrease from 1.8 kN to 1.3 kN (28% decrease). The cracks shown in Figure 7 and the debonded areas of Figure 8 were not detected by our X-ray, ultrasonic scanning, or Eddy current efforts. Fiber fractures were readily detected by De Goeje and Wapenaar (4) with an Eddy current method. It is noted here that their method uses high frequencies (30 MHz) and is successful when at least 8% of the total composite's thickness bears fiber cracks. Since a limited number of fiber breaks were found in the failed disks, it is not surprising that our Eddy current efforts were not successful.

Figure 9. Ultrasonic scan with single delamination.
